Catherine Creek State Park Restoration Project

1984-025-00

Contract # 74313 Rel 54

Report covers implementation from: April, 2022 – November, 2022

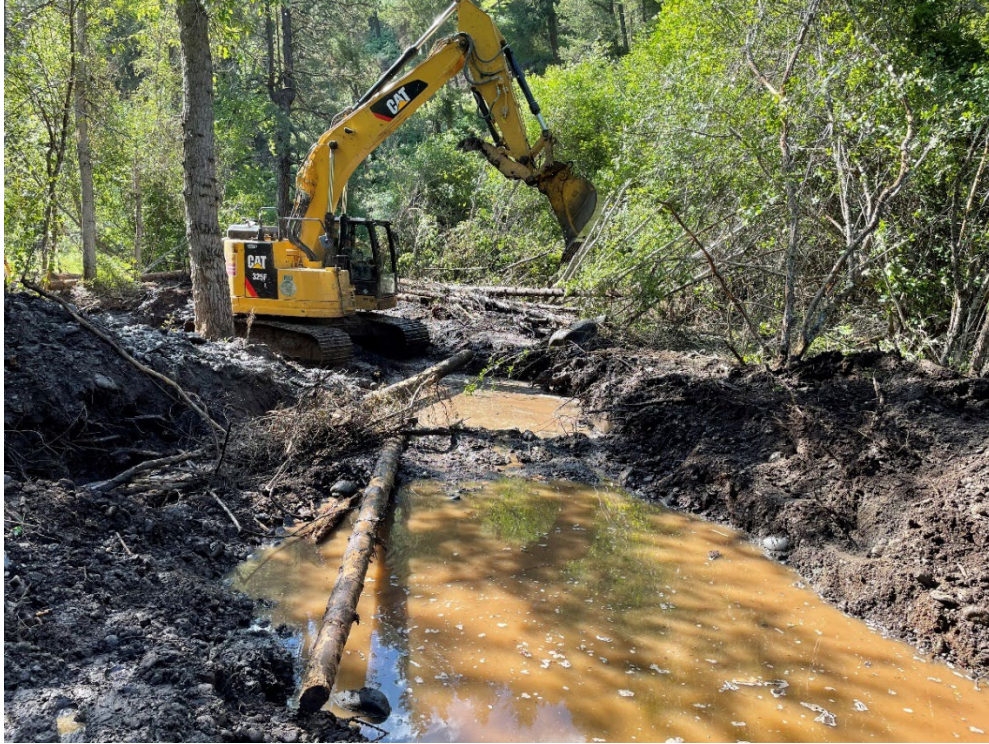
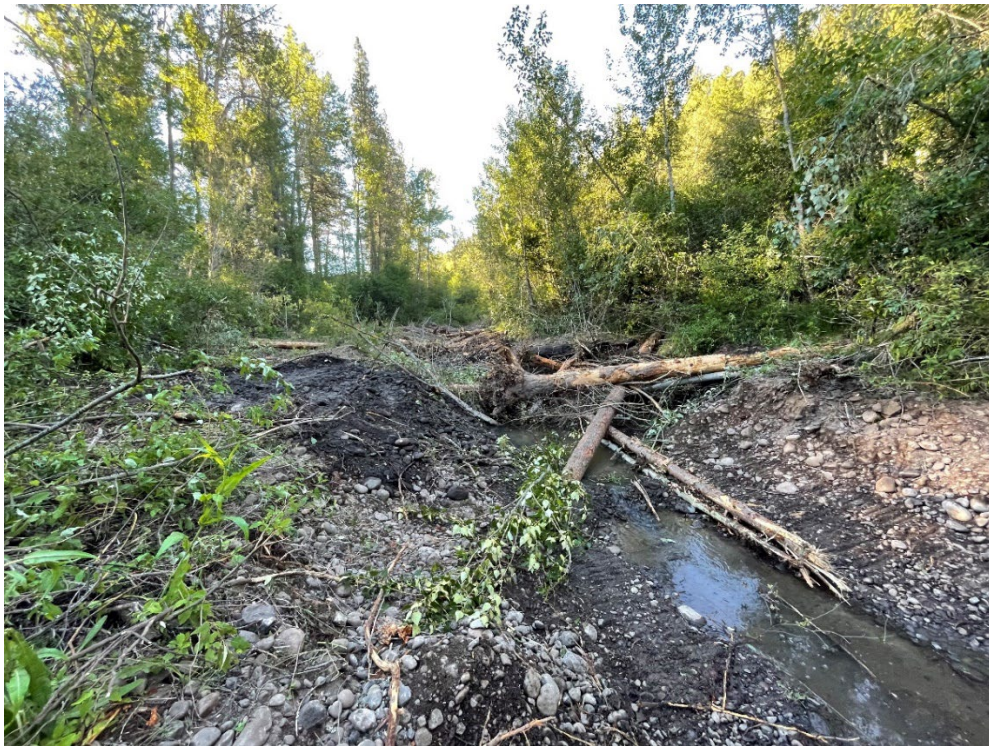
Figures 1 and 2. Installation of LWD structure in newly constructed side channel and the completed side channel and large wood structures before activation.

Side channel creation: A side channel was excavated along a historical channel scar that has been abandoned by a channel avulsion. Constructed wood jam habitat enhancement features were added at strategic locations. Reconnection of the side channel is expected to provide flows conducive to riverine wetland development.

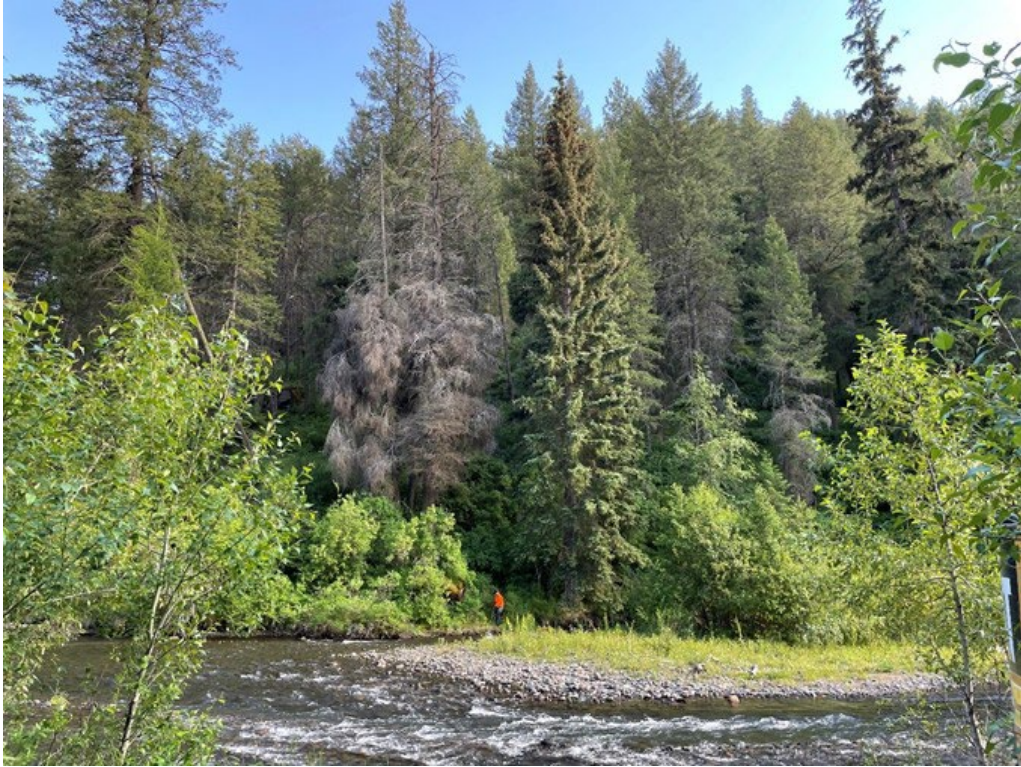
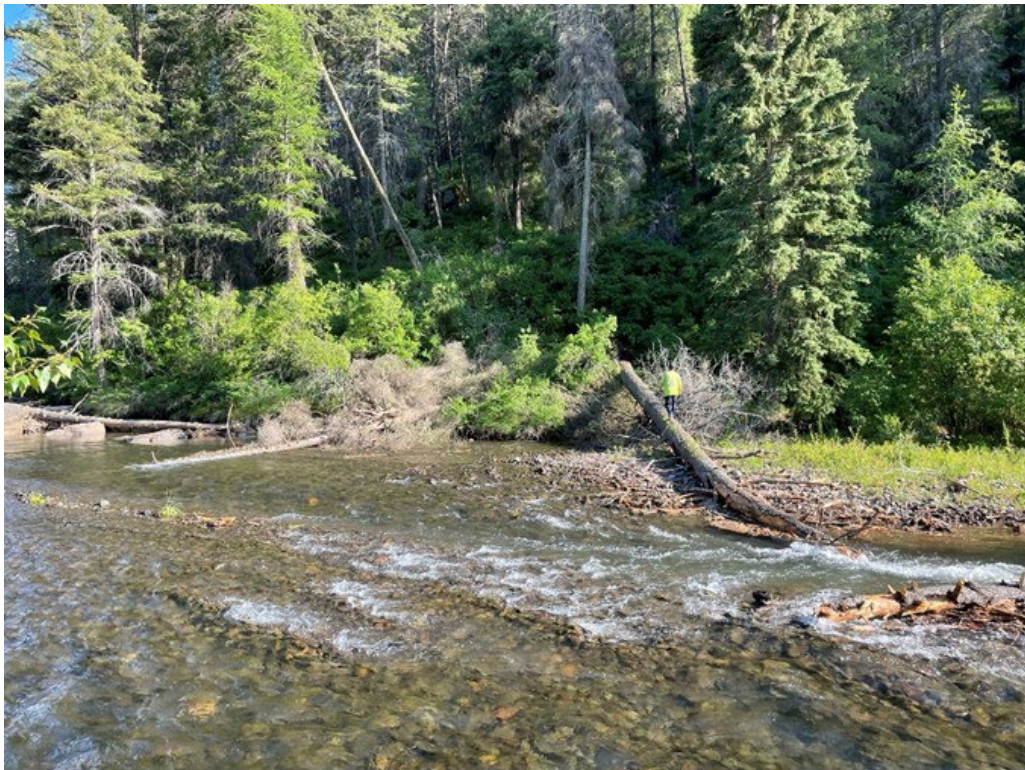
Figures 3 and 4. Before and after two bank trees were pulled over. Note people in both images.

Our program had never had the opportunity to get to tip trees on-site right into the river so the addition of “Hillslope Wood” was a new technique for us. We were able to complete this project element utilizing a 300 series excavator, 200’ of cable, chokers, and a chainsaw auger. Chokers were secured 15-20 feet up the trunk and the soil was loosened up around the base of the tree. The excavator was located on the opposite side of the creek in order to be able to safely pull the tree over. This technique has been shared with the Upper Grande Ronde Implementation Team partners so they can utilize it in the future if needed.

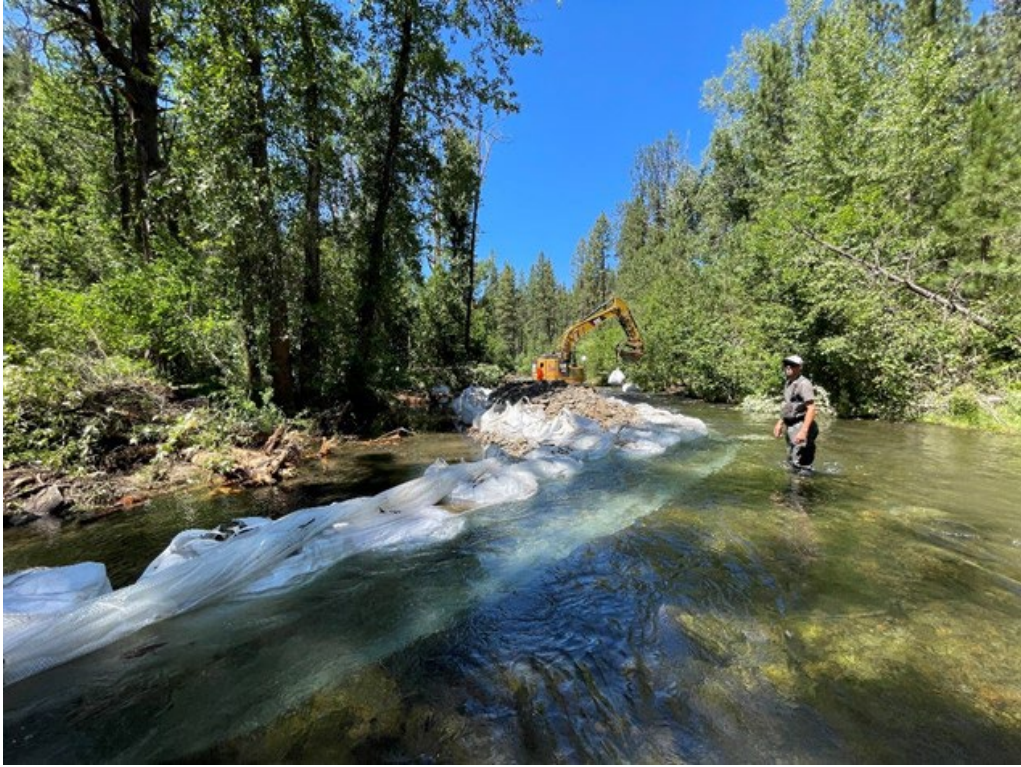
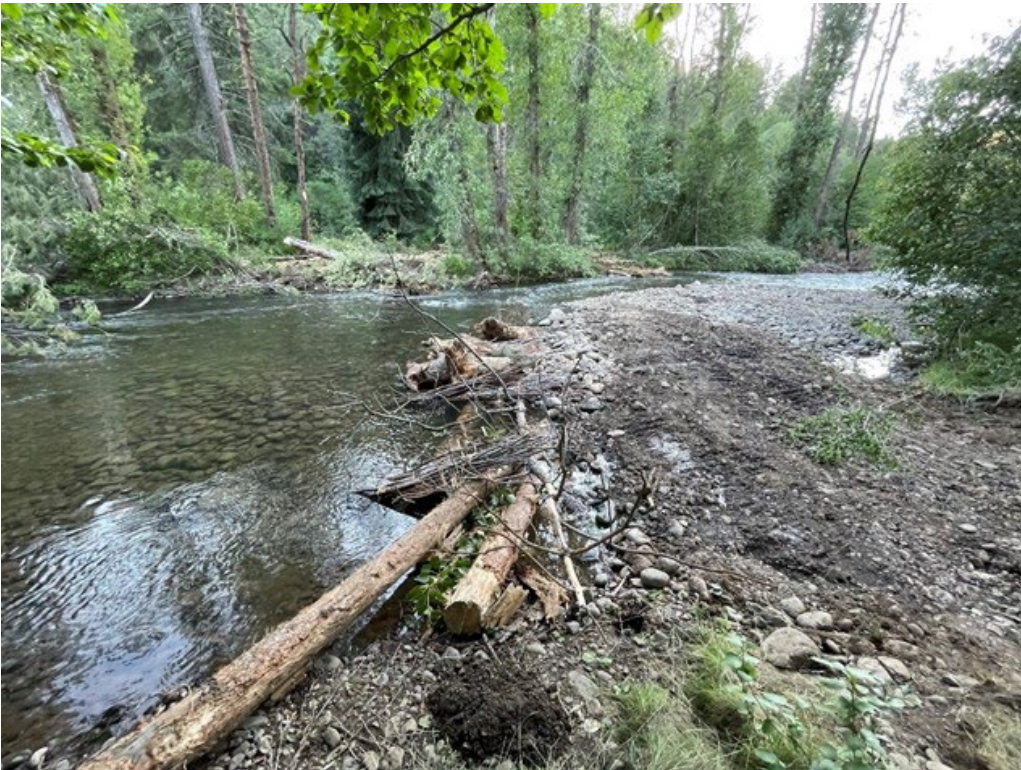
Figures 5 and 6. Construction of Pool-Bar-Wood complex and built Pool-Bar-Wood complex. Note width to depth reduction.

Gravel Bar and Pool Enhancement: At two locations in the upstream portion of the project, gravel bars were created utilizing on site materials to narrow the channel and provide planform complexity within a portion of the channel that had simplified plane-bed morphology. It is expected that area of riverine wetlands will increase on the seasonally inundated bars and pool features will exist where there were previously none.
