# **Upper Grande Ronde-Bowman Fish Habitat Enhancement Project**

1984-025-00 and 1992-026-01

Report covers work performed from: June, 2023 – November, 2023

Winston Morton, Nicholas Smith  
Oregon Department of Fish and Wildlife  
La Grande, Oregon  
December, 2023

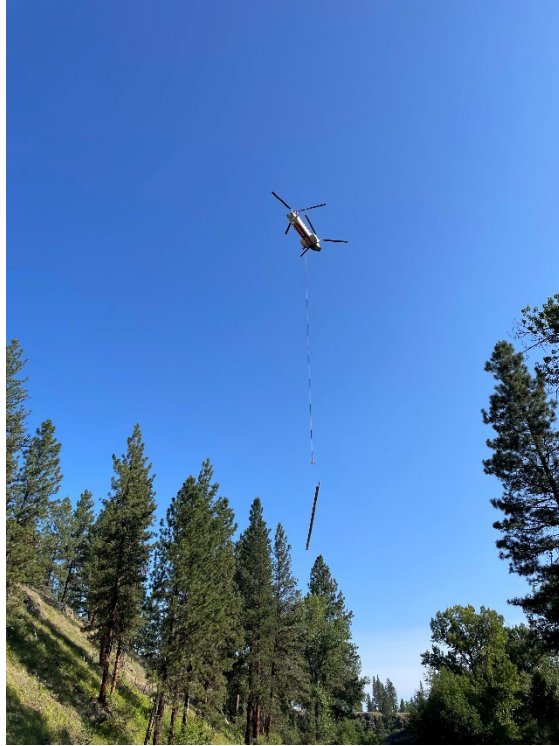
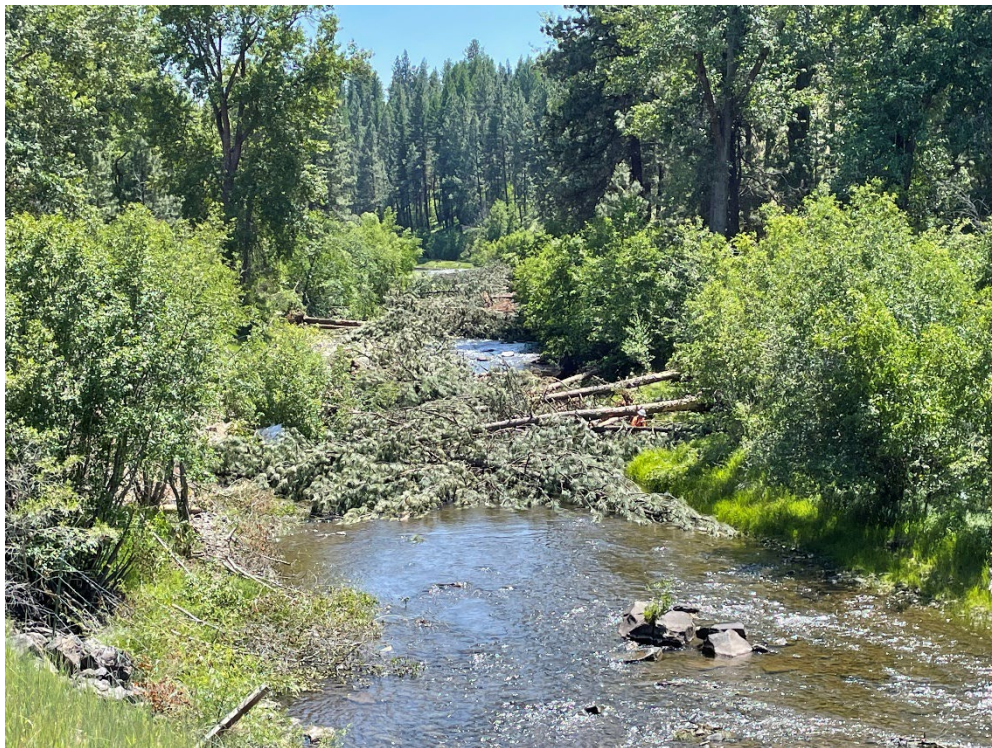
**Figures 1 and 2.** Installation of Large Wood Accumulations using a Vertol 107 and view upstream of placed wood before substrate augmentation.

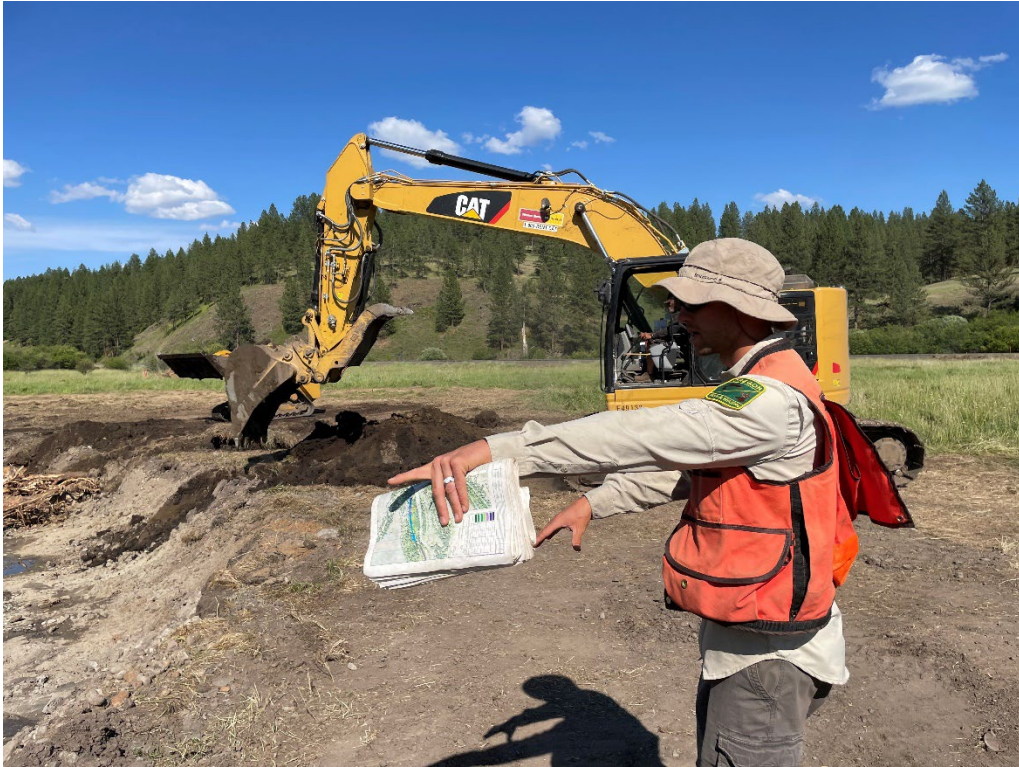
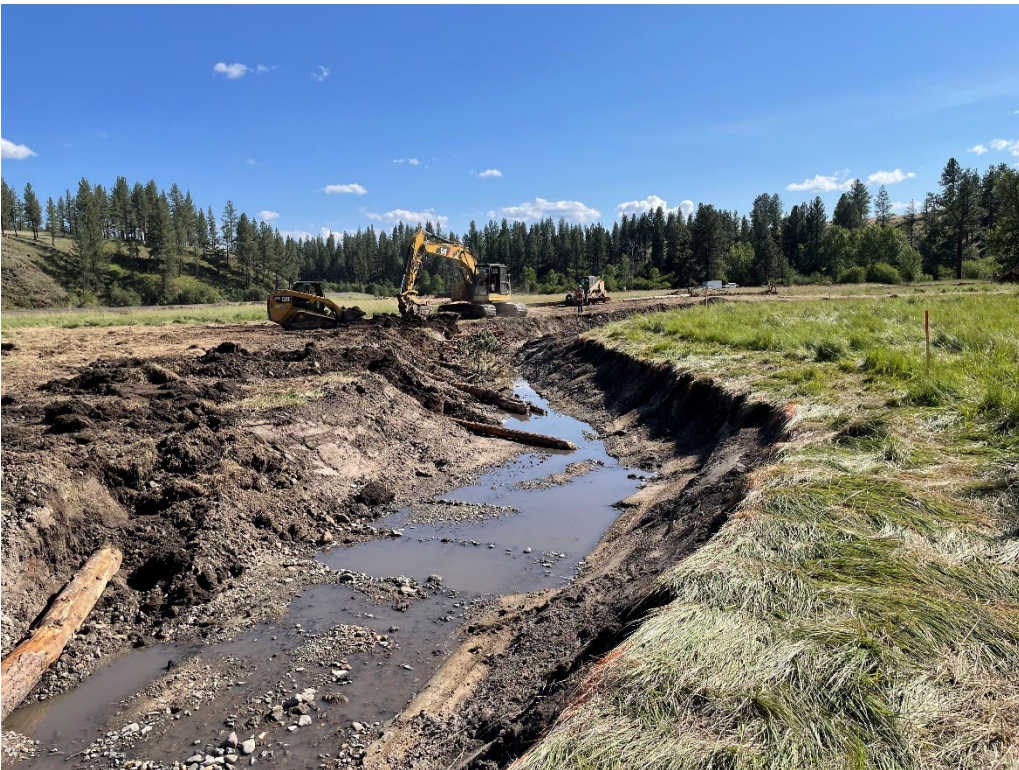
**Figures 3 and 4.** ODFW staff directing large wood placement in the recently constructed side channel.

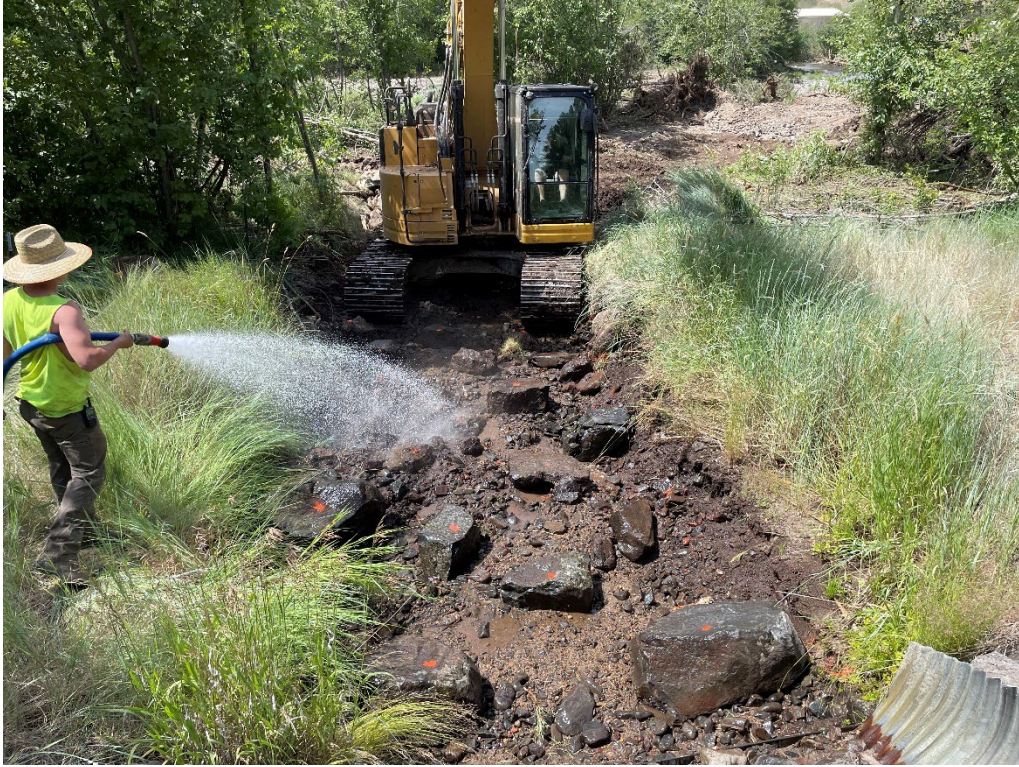
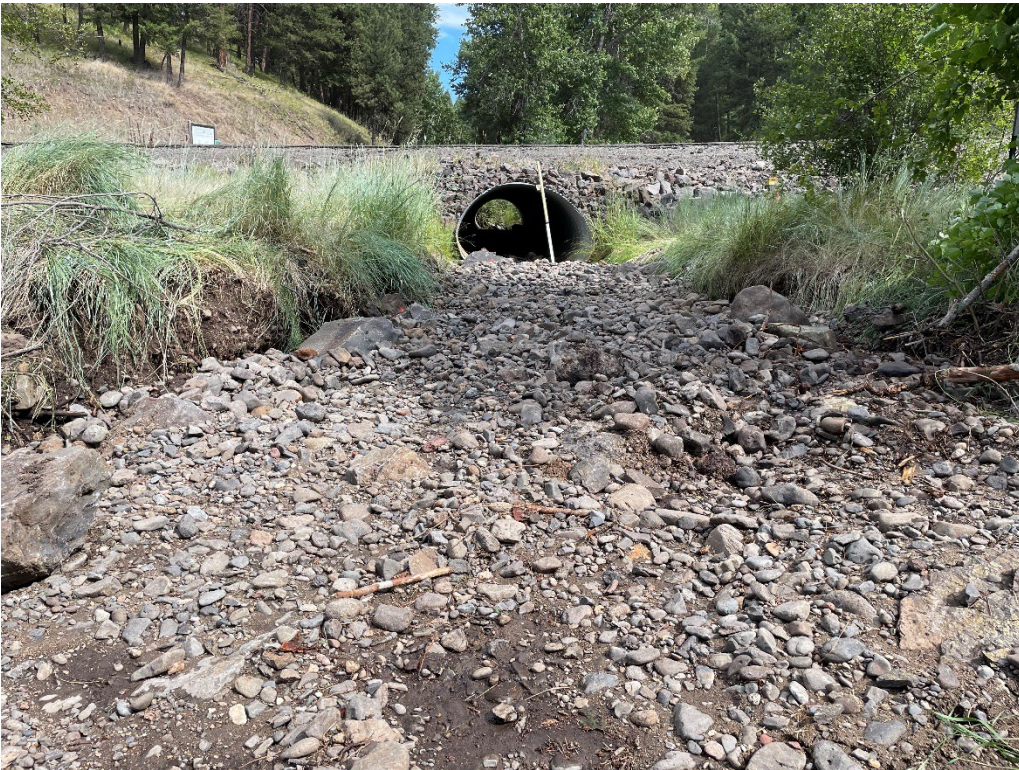
**Figures 5 and 6.** Construction of the Warm Springs Creek alluvial fan and channel.
