PROJECT COMPLETION FORM

HIP No: 2021083

Project Title:	Wallowa River McDaniel		
Date of Submittal:	5/3/2022		
BPA Project #:	1992-026-01	Contract #:	79905 Rel 5

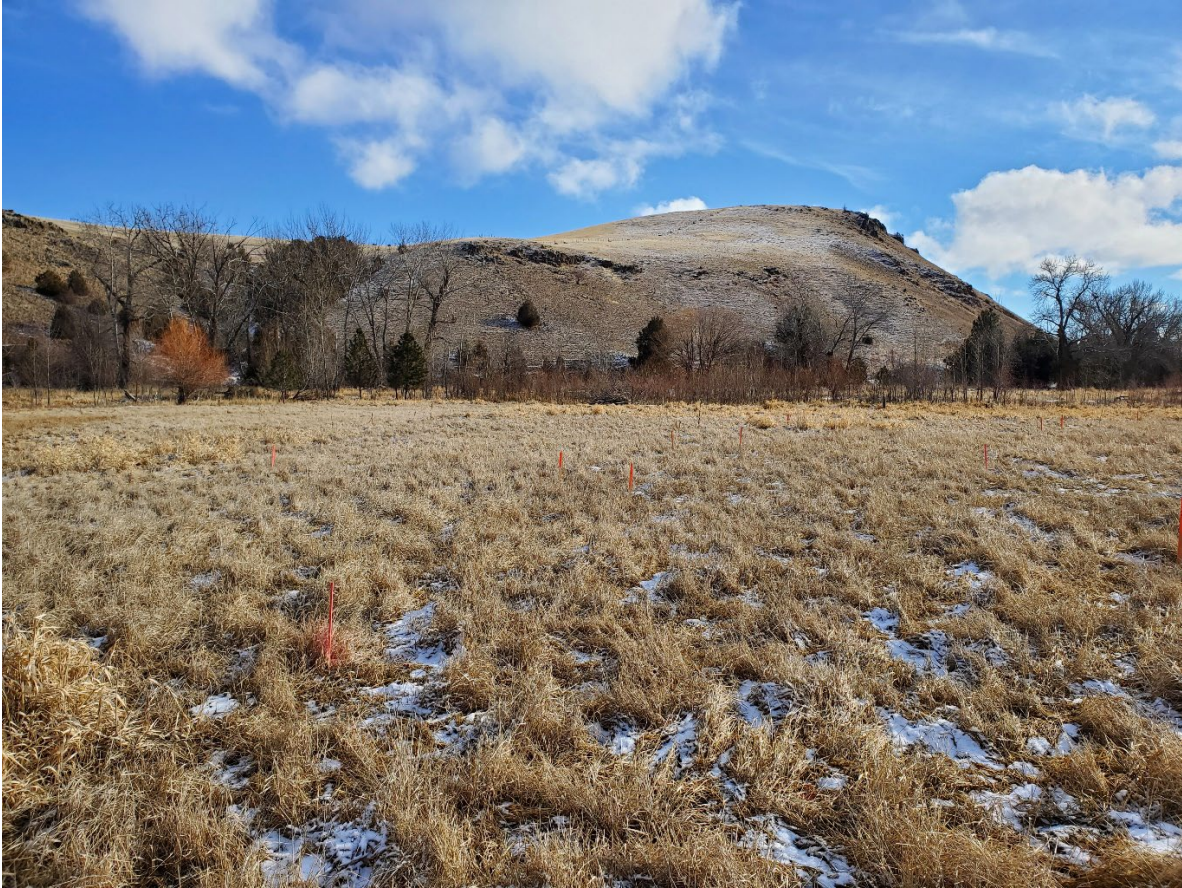
Upstream view of Side-channel 1 prior to construction on 01/26/2021.

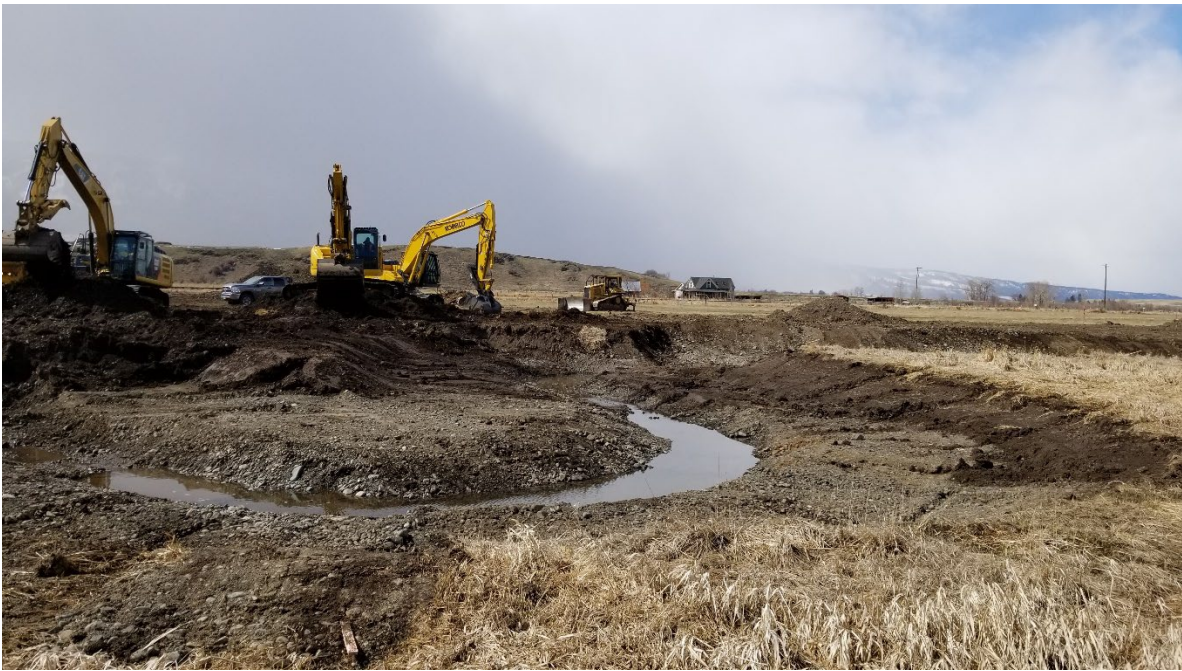
Looking downstream at the same reach of Side-channel 1 during construction on 03/29/2021. Channel was dug “in the dry” outside of the in-water work window.

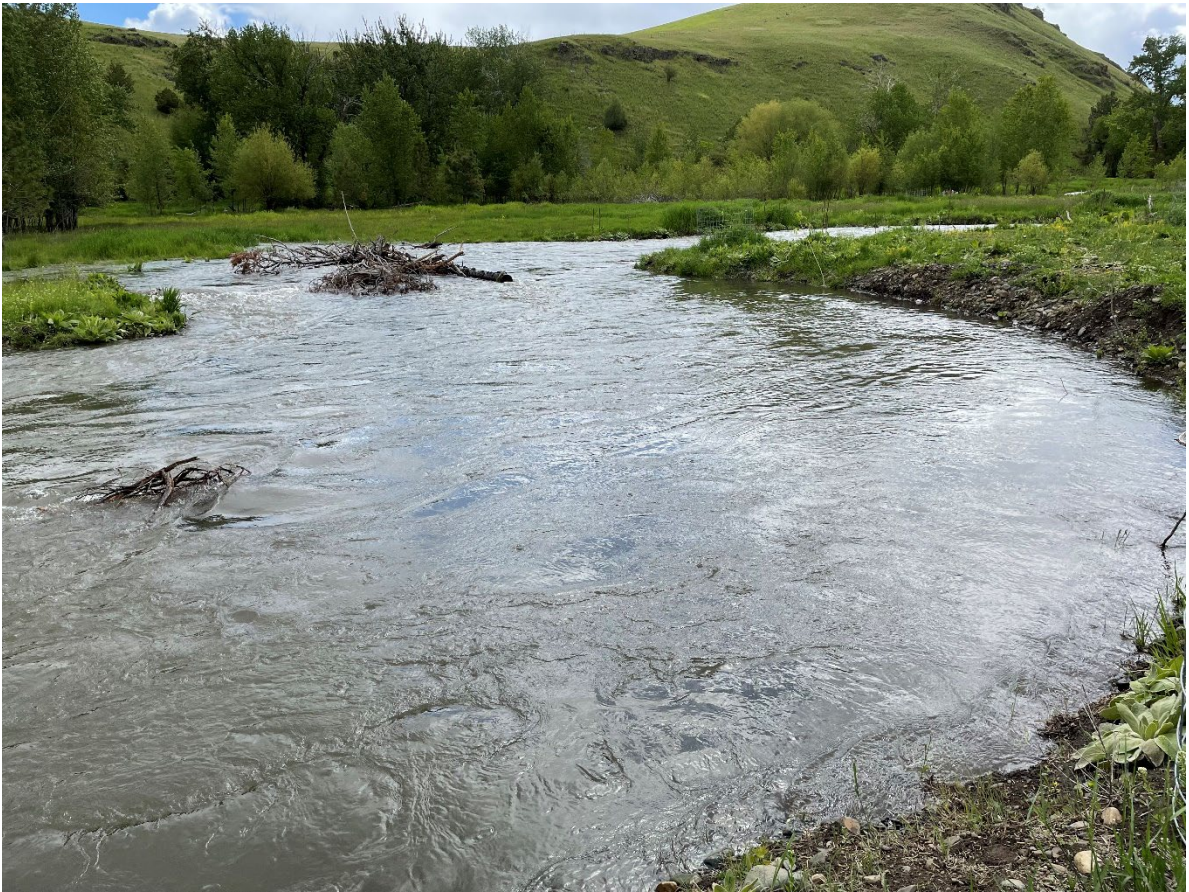
Upstream view of Side-channel 1 on 06/06/2021 during high water from a similar location as the first image.

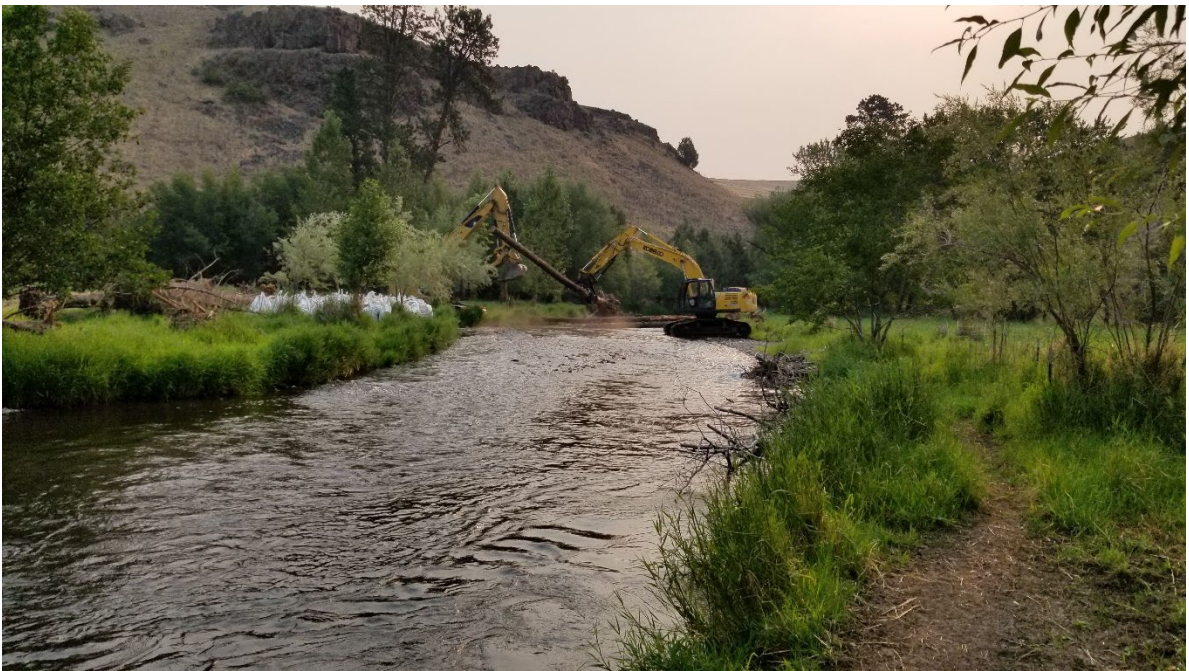
Upstream view of location where apex LWD structure will be installed on 07/15/2021.

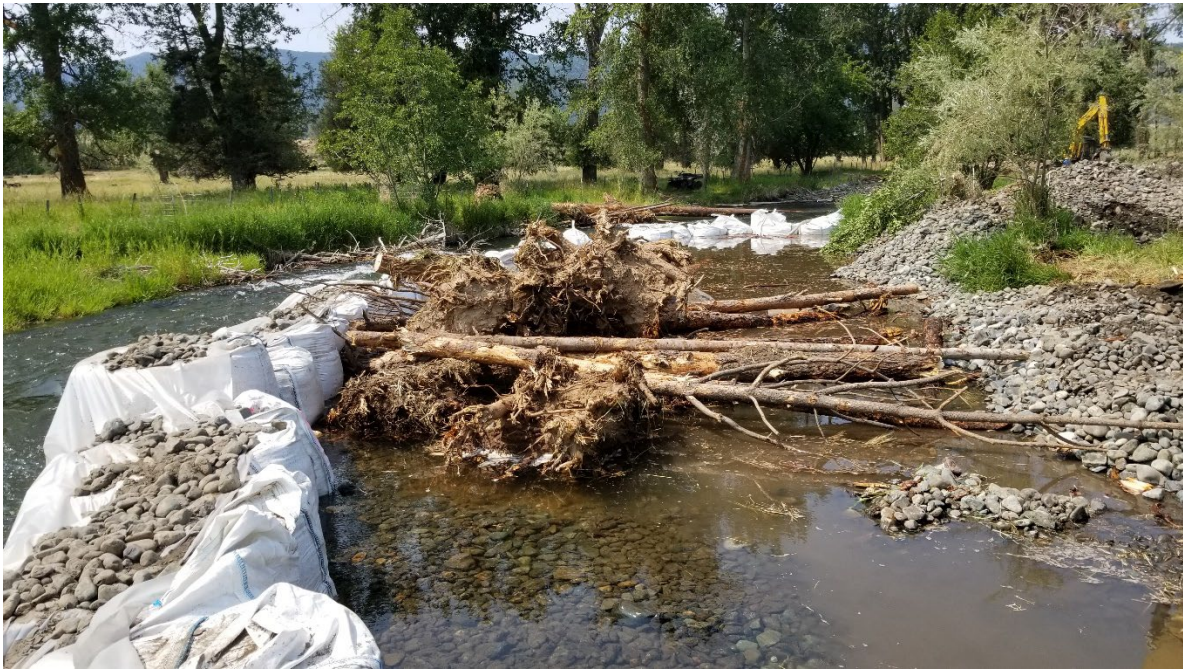
Downstream view of apex LWD during isolation and construction on 07/16/2021.

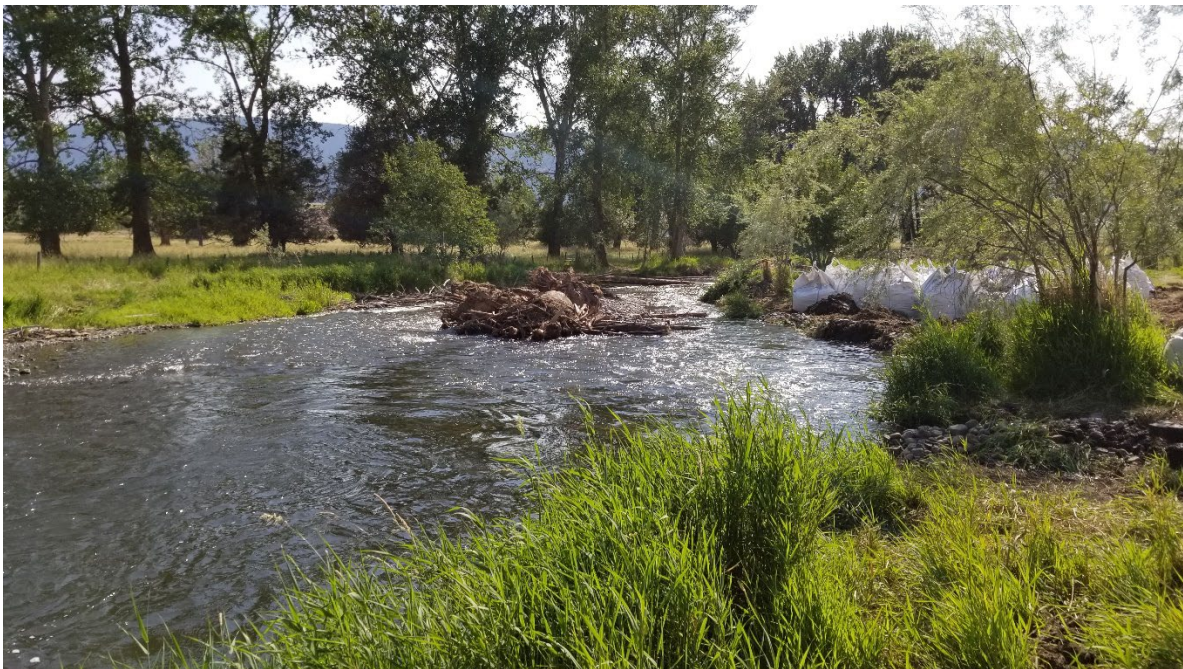
Downstream view of apex LWD after installation and removal of isolation on 7/16/2021.
