Willow Creek Fish Passage Project (Huber)

Atlas Tier III, UGR4

Implementation: 2022; Contract #: 90574

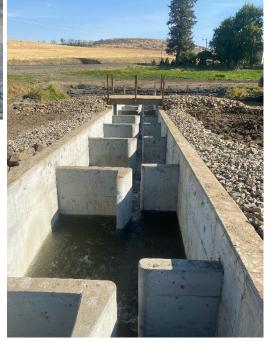
Post Project Conditions

IMPLEMENTATION ACTIONS: The project constructed a 100-foot long, 10-foot wide vertical slot fishway at the Huber Dam site. The fishway consists of 10 bays with vertical weir walls to maintain the hydraulic drop throughout a range of flows. A 4-inch orifice was constructed at the bottom of each bay wall and radius corners were built into each weir to accommodate pacific lamprey passage. In addition to the fishway, a grade control structure was constructed in the Willow Creek channel to maintain channel bed elevation at the fishway entrance. An encapsulated soil lift was constructed along the river left streambank, across from the fishway entrance to ensure bank stability and promote riparian vegetation. Approximately 700 willow stakes were planted in the encapsulated bank and all disturbed areas were seeded with site appropriate herbaceous seed mixtures.
