Willow Creek Fish Passage (Huber)

Project#:1992-026-01

Habitat Completion Report

Union Soil and Water Conservation District

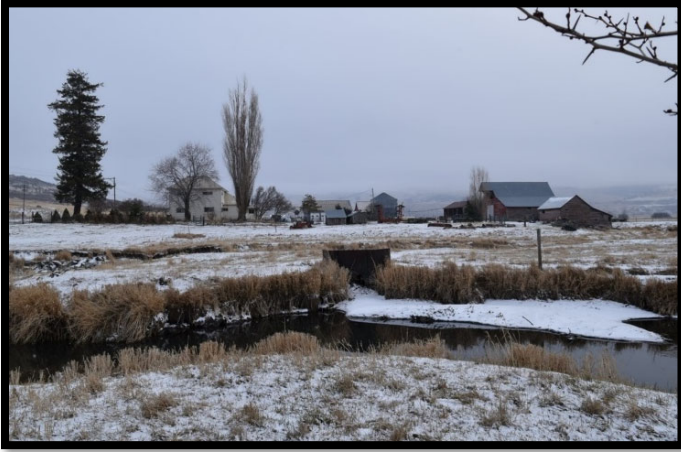
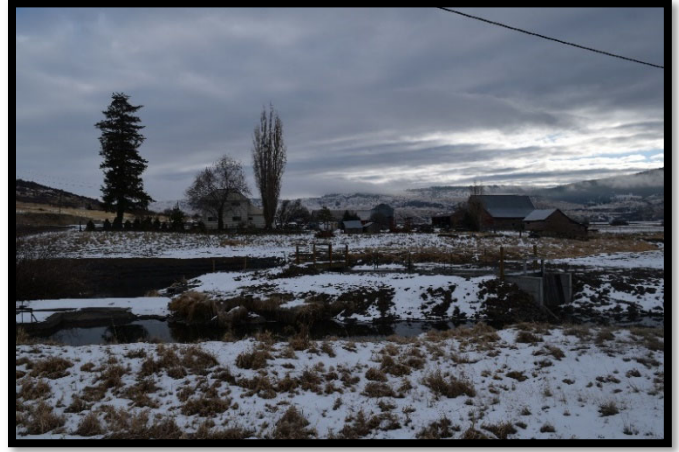
Figure 1. Pre- and Post- project at the Huber Dam backwater.

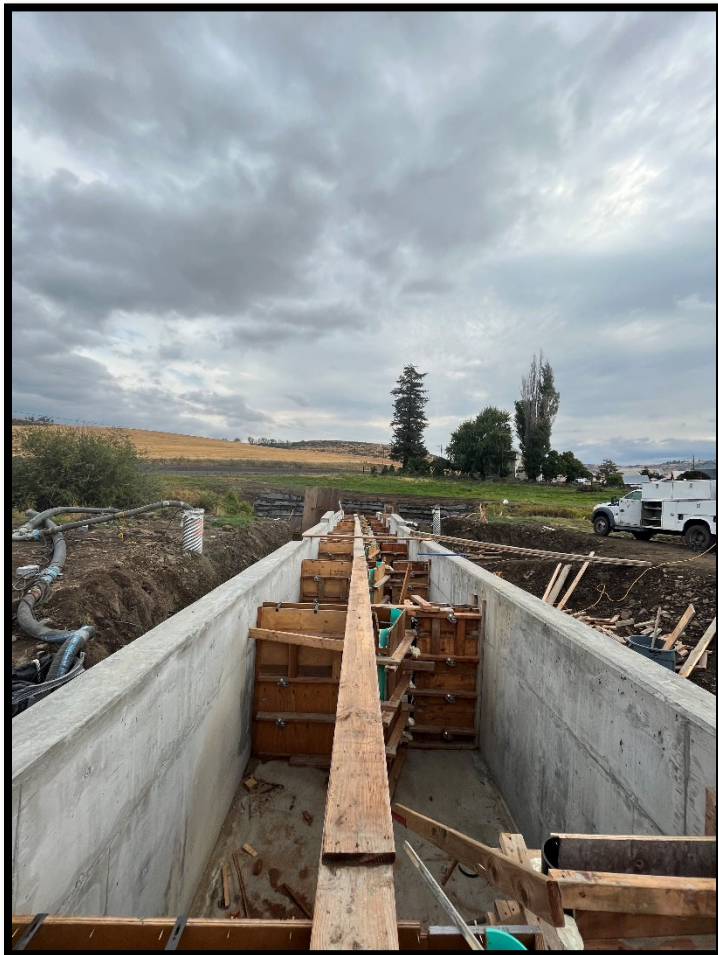
Figure 2. Huber Dam Fishway construction, weir wall forms.

The project constructed a 100-foot long, 10-foot wide vertical slot fishway at the Huber Dam site. The fishway consists of 10 bays with vertical weir walls to maintain the hydraulic drop throughout a range of flows. A 4-inch orifice was constructed at the bottom of each bay wall and radius corners were built into each weir to accommodate pacific lamprey passage. In addition to the fishway, a grade control structure was constructed in the Willow Creek channel to maintain channel bed elevation at the fishway entrance. An encapsulated soil lift was constructed along the river left streambank, across from the fishway entrance to ensure bank stability and promote riparian vegetation. Approximately 700 willow stakes were planted in the encapsulated bank and all disturbed areas were seeded with site appropriate herbaceous seed mixtures.

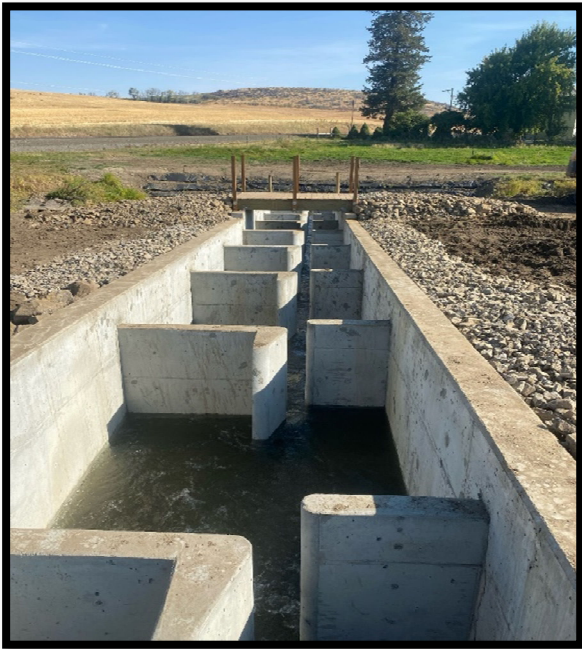
Figure 3. Huber Dam Fishway activated with flow.

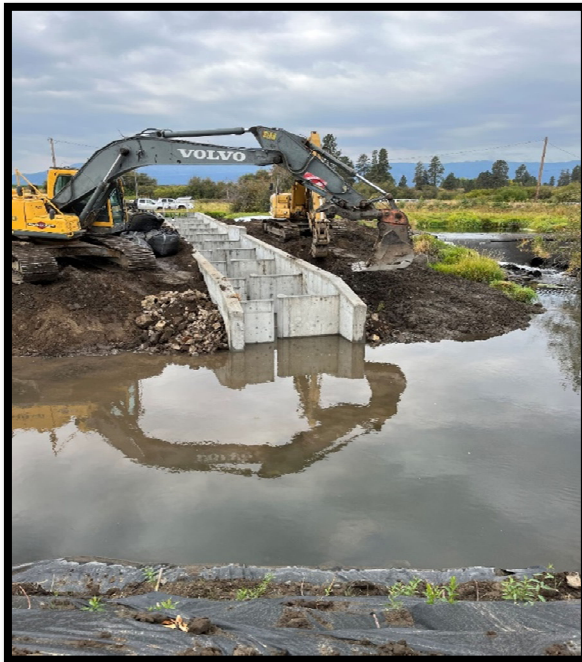
Figure 4. Huber Dam Fishway, installation of surrounding rock apron.

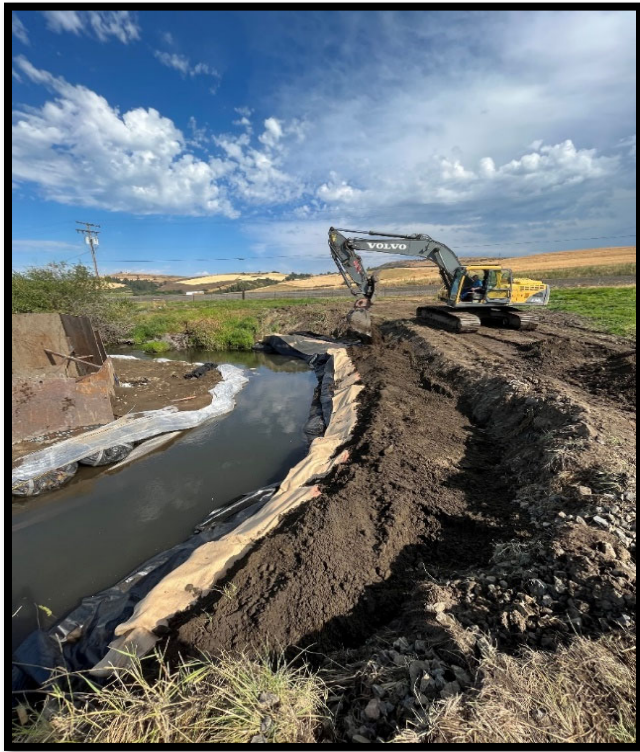
Figure 5. Construction of encapsulated soil lift.

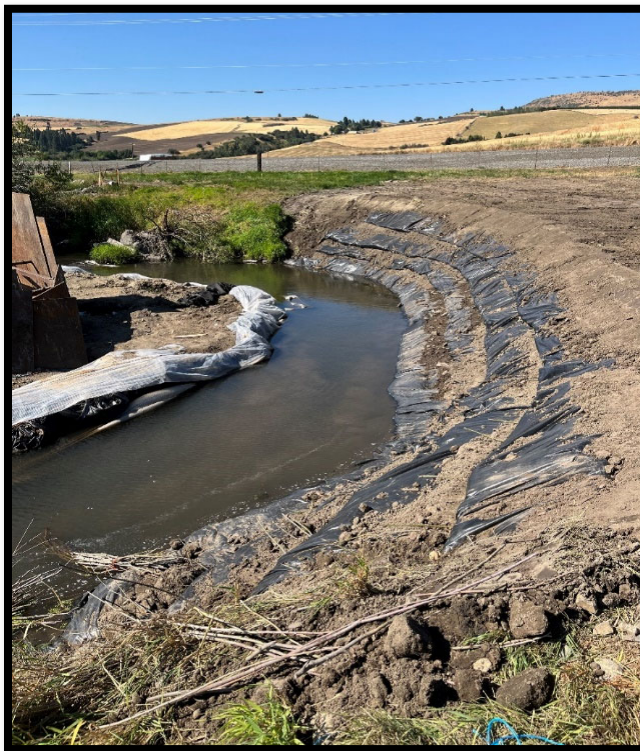
Figure 6. Completed encapsulated soil lift.
